<h1>SERVICE BULLETIN</h1>		Aircraft type:	ALTO 912 TG ALTO NG
	No. SB-0-002-2024-EN	MANDATORY	Revision:	00

<u>Applicability:</u>	S/N: DF125, DF160, DF176, DF200, DF202, DF213
<u>Concurrent ASB/SB/SI and SL:</u>	None
<u>Reason:</u>	Yaw control path fuselage structure collision (in the case of pedals with shifted position installation)
<u>Subject:</u>	Perform manual repair according to instructions
<u>Compliance:</u>	Immediately, before next flight
<u>Approval:</u>	Inform manufacturer
<u>Labour time:</u>	0.5 hr
<u>Mass data:</u>	Change of weight: none Change of CG: none
<u>Electrical load data:</u>	None
<u>Software modifications:</u>	None
<u>References:</u>	None
<u>Other Publications affected:</u>	None
<u>Interchangeability of part:</u>	None

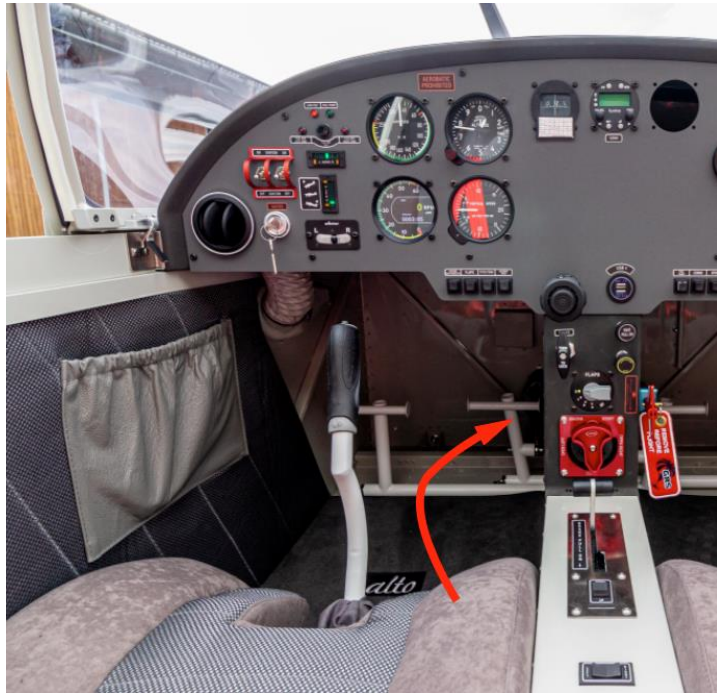
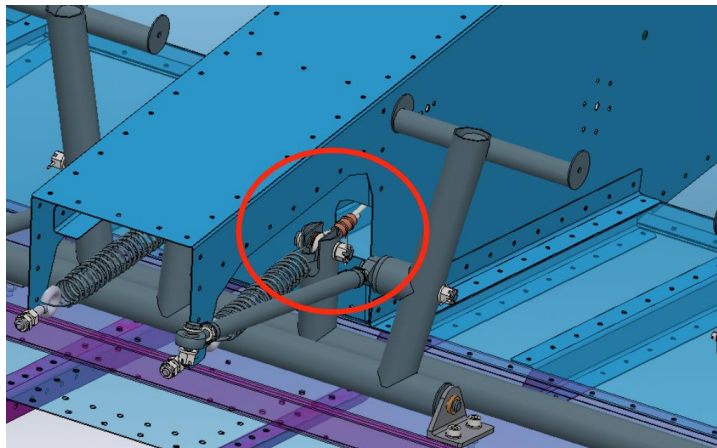
- 1) Collision takes place below and behind the instrument panel.

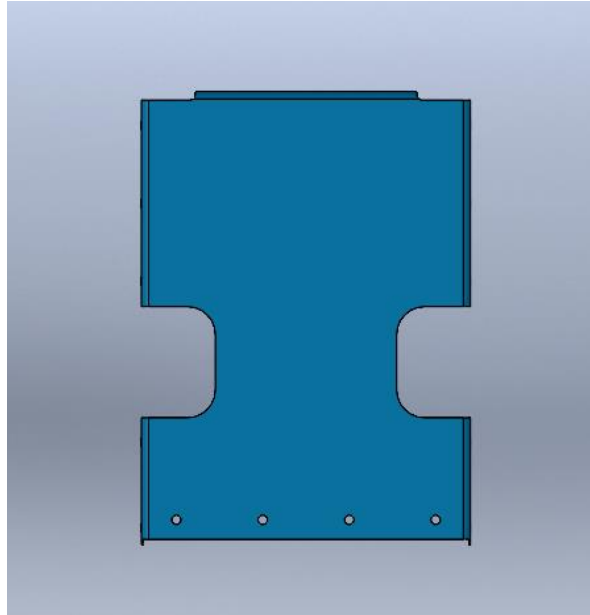
- 2) Frame which is affected is numbered as 2_02_11_09:

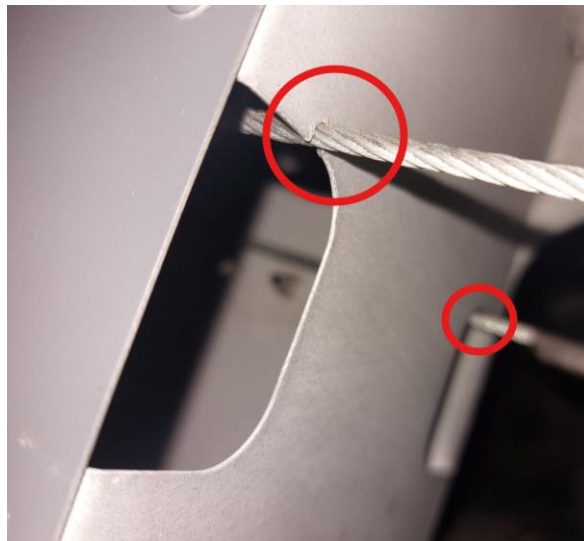
- 3) In the case of shifted pedals installation (in direction to the firewall) there is a collision between the control cables and the fuselage structure.

- 4) In such a place there is a need for the cutaway to be expanded. Also check for the condition of control cables (look for any wear and fraying). Pay attention when performing the cutaway. Make sure that your tooling will not interfere with control cables. The cutaway must be performed on both sides (left and right cable).
- 5) Enhanced hole must allow for the free movement of the cables without any further collision. Gap of 5mm between the cable and sheet metal can be considered as satisfactory.
- 6) Sharp edges must be sanded. Example of the hole enlargement:
